Doc. No.: MD10-WOI-32-001
Type: JS-MD Series	Subject: Work Instruction	ATA: 32
Model/s: JS-MD 3	Title: Tailwheel Main Shaft Inspection	Rev.: 00

Title: Tailwheel Main Shaft Inspection
Work Instruction

This document contains all necessary steps to complete the content of the Service Bulletin SB-MD10-005

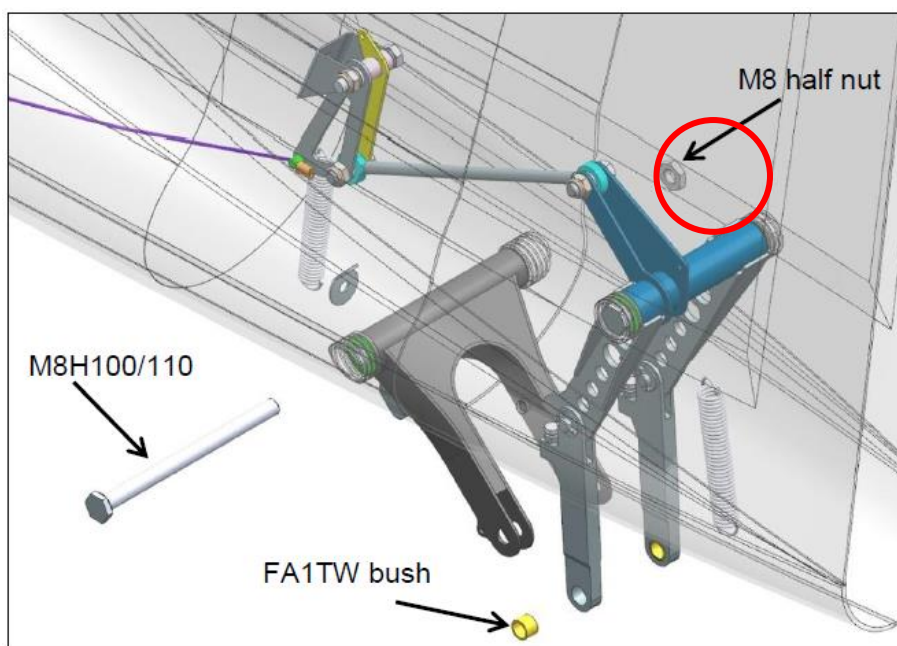
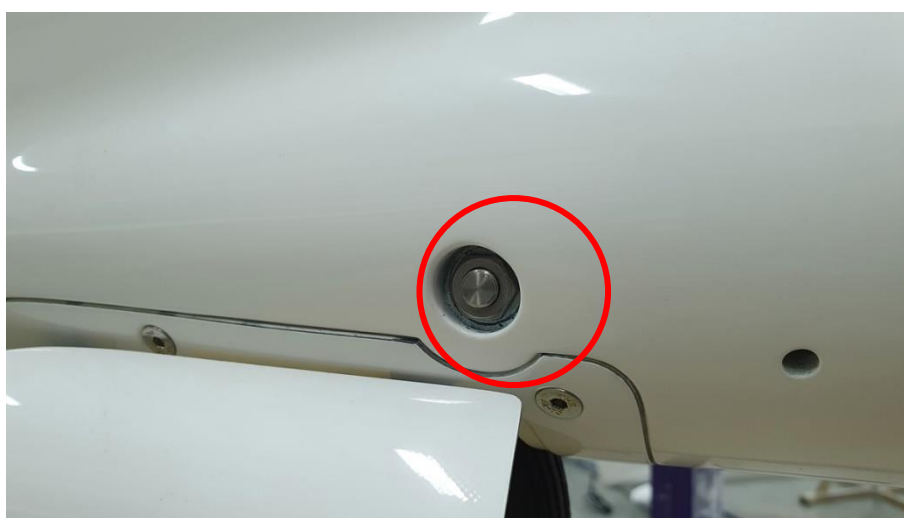
1. Inspect whether the M8 locknut (half nut) of the tailwheel main bolt is installed. The nut in question can be found on the right hand side of the fuselage and is indicated below:

2. If this locknut is not installed, the rectification procedure in Section 5.2 should be followed.

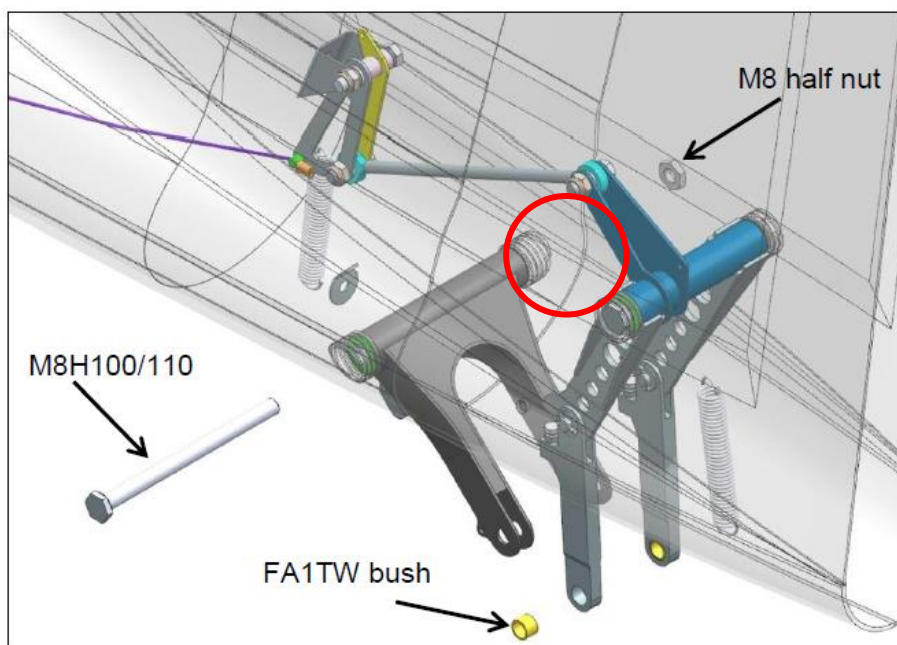
1. Clean the thread of the M8H100/110 bolt.
2. Ensure the M8H100/110 bolt is installed and screwed into the threaded aluminium insert that is built into the right hand side skin of the fuselage. Do not overtighten the main bolt as all the moving parts still need to be able to move freely after the installation. The threaded insert is indicated below:

3. Apply a small amount of Loctite 243 on the thread of the main bolt protruding on the right hand side of the fuselage.
4. Install the M8 locknut (half nut) and tighten. The torque spec for this M8 half nut is 14.0 Nm – 19.0 Nm. After the nut has been installed, the bolt has to at least sit flush with the nut or protrude from the nut.
5. Test the operation of the tailwheel.
