Doc.: SB 808-34-R00 **Date:** 18.06.2021 **Page:** 1 of 4

Optional Service Bulletin

SB 808-34

Slotted hole modification of the elevator mass balance.

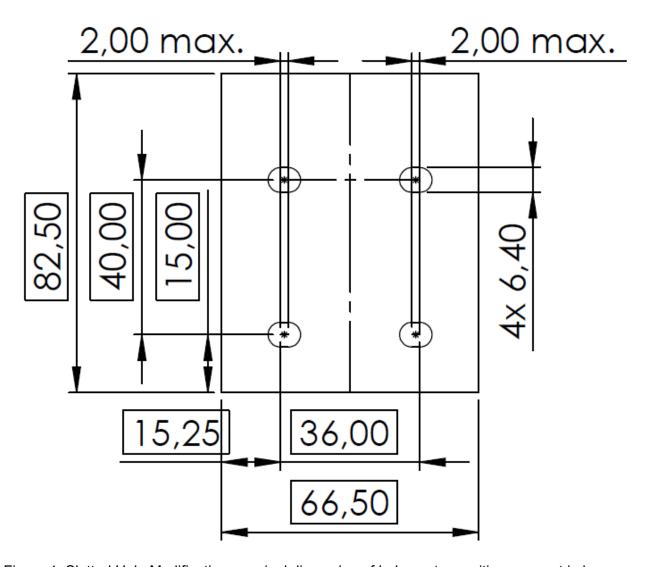
Diverging bore positions in elevator spar of older AVo68-v S/N's.

Figure 1: Slotted Hole Modification; nominal dimension of hole centre positions are put in boxes

Modification of the elevator mass balance mounting holes. The holes are slotted symmetrically to the symmetry plane of the part until installation is possible. A maximum material removal of 2mm is allowed, see Figure 1. Material should only be removed, until the mounting of the part is possible. Thus, a measurement of the hole positions is obligatory.
