Service Letter

SL-MD10-004-R00

Jet JDU Firmware Update

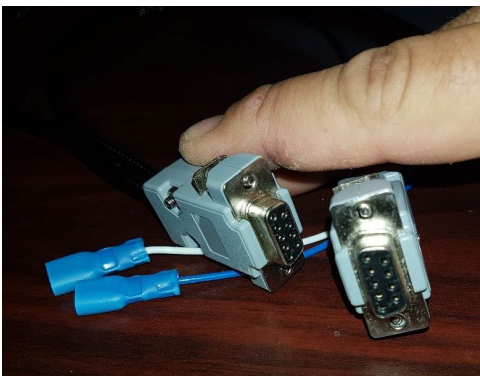
The JDU serial cable with 12V power supply can be manufactured according to the following figures:

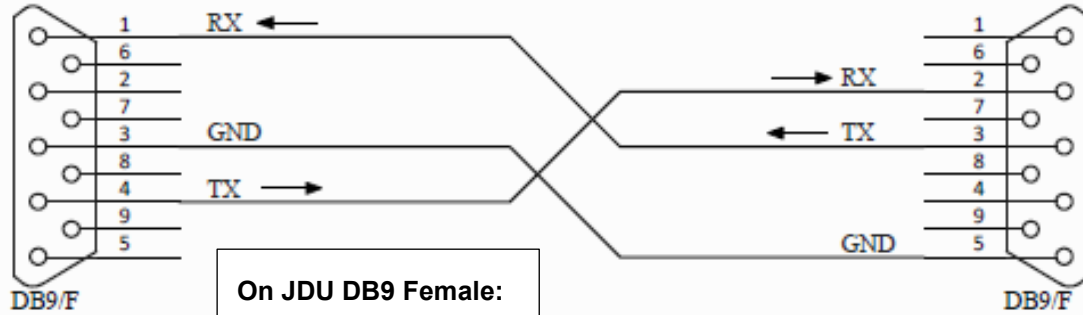
JDU DB9 Female

PC DB9 Female
